**MARYLAND HISTORICAL TRUST  
NR-ELIGIBILITY REVIEW FORM**

Property Name: Mill Inventory Number: HO-420

Project: Owens Property Agency: Corps of Engineers

## INVENTORY FORM FOR STATE HISTORIC SITES SURVEY MAGI#1404205714

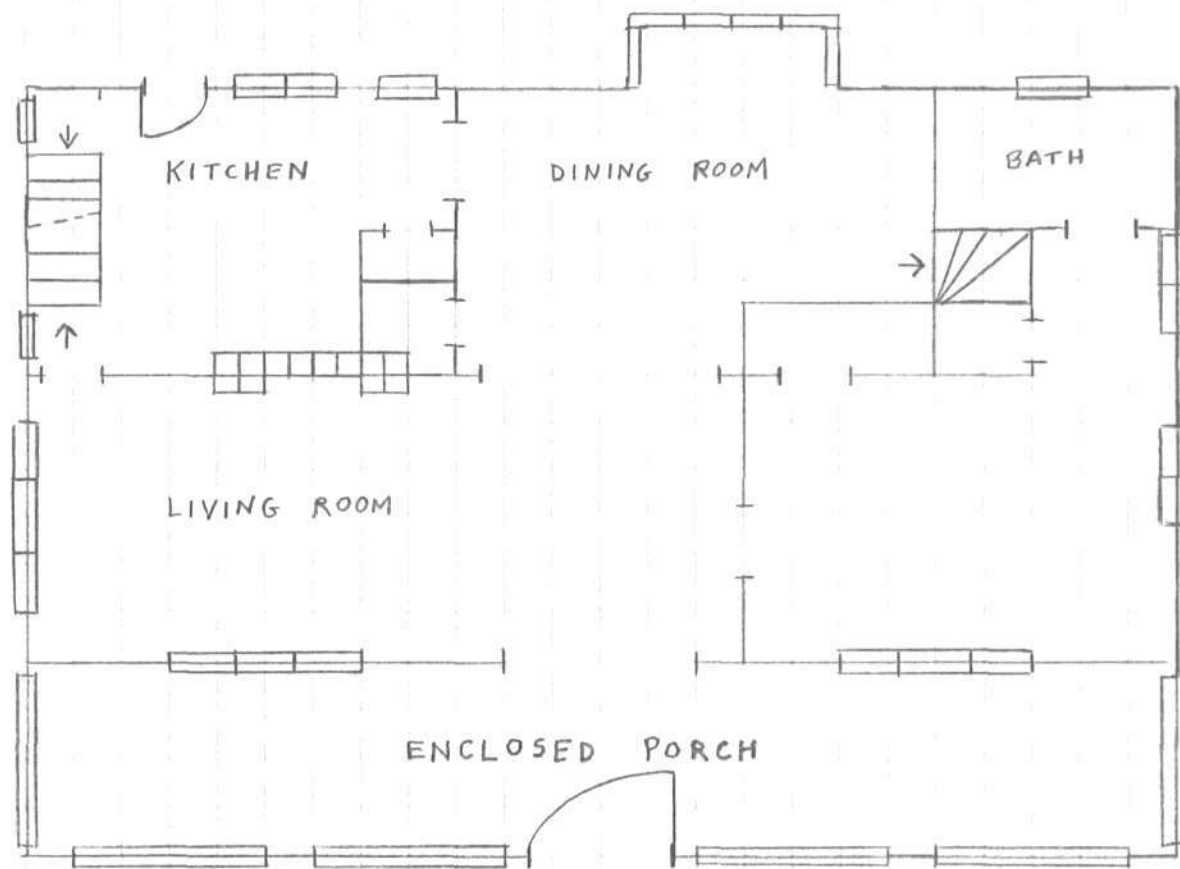
Main House  
First Floor  
Not to scale

The interior of the house features narrow wood floorboards and plaster walls on the first and second stories. A rebuilt brick-veneer fireplace with a wood stove is located in the living room. (See attached floor plan.) The house is in fair condition. Exterior paint is deteriorating on the wall siding, eaves, and window frames. Deteriorated wood was noted on some of the wall siding, as well as on the front and rear doors. The metal roof is rusting and discolored.

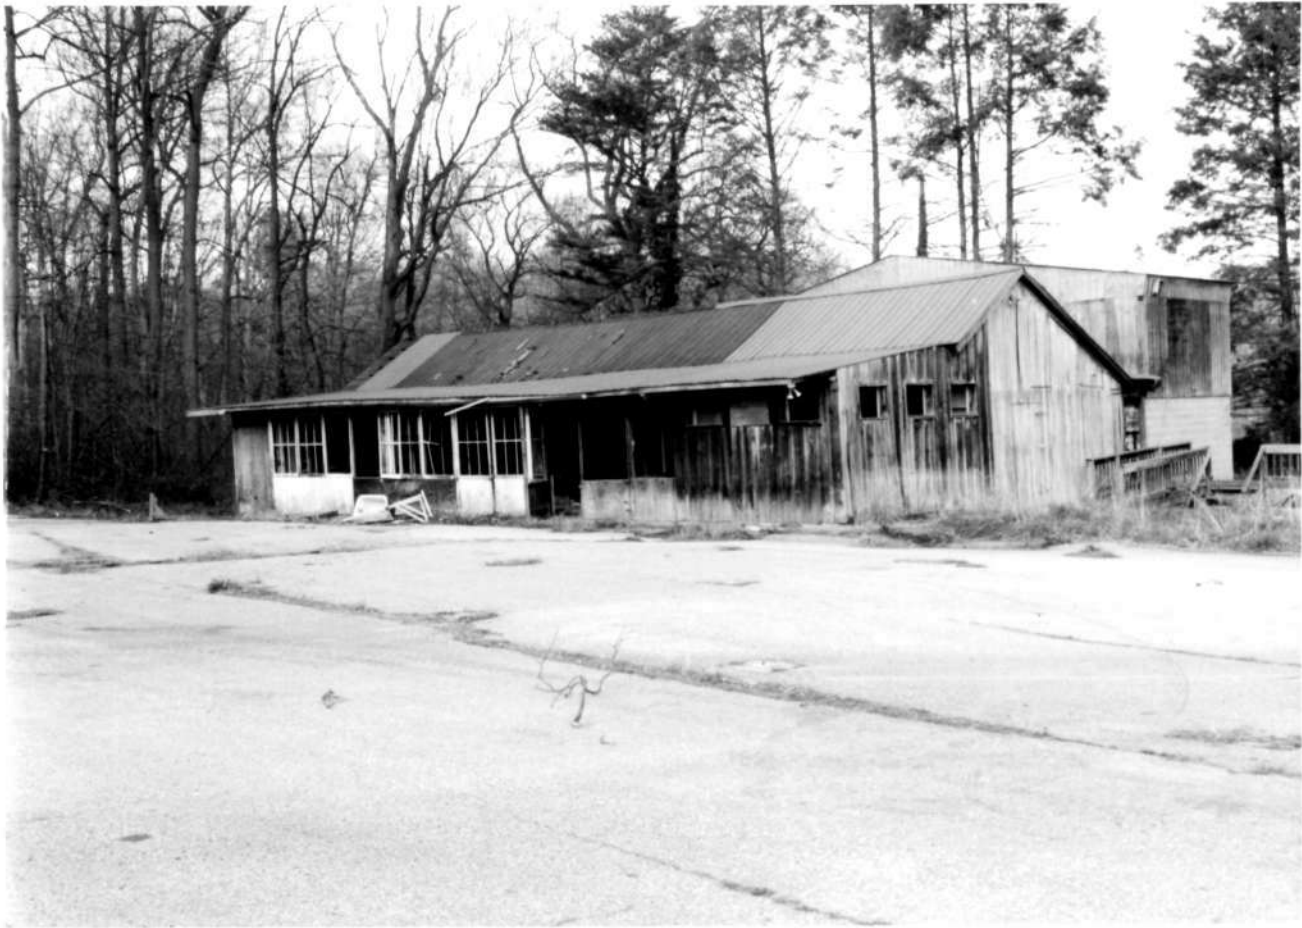
1/24

The **cider mill** is located off a short driveway leading from the southwest side of Landing Road. The cider mill, built ca. 1916, faces southwest towards an asphalt parking lot. The cider mill is one-story, wood-frame building comprising five, single-pile, structural bays. The side gable-roofed building includes a full-width front addition and a three-quarter-width rear addition. The southeast end bay of the principal block originally rested on concrete piers. The piers were infilled with concrete block ca. 1960 and a concrete slab floor was added ca. 1990. The four remaining bays rest on a poured concrete slab.

Cider Mill, view N

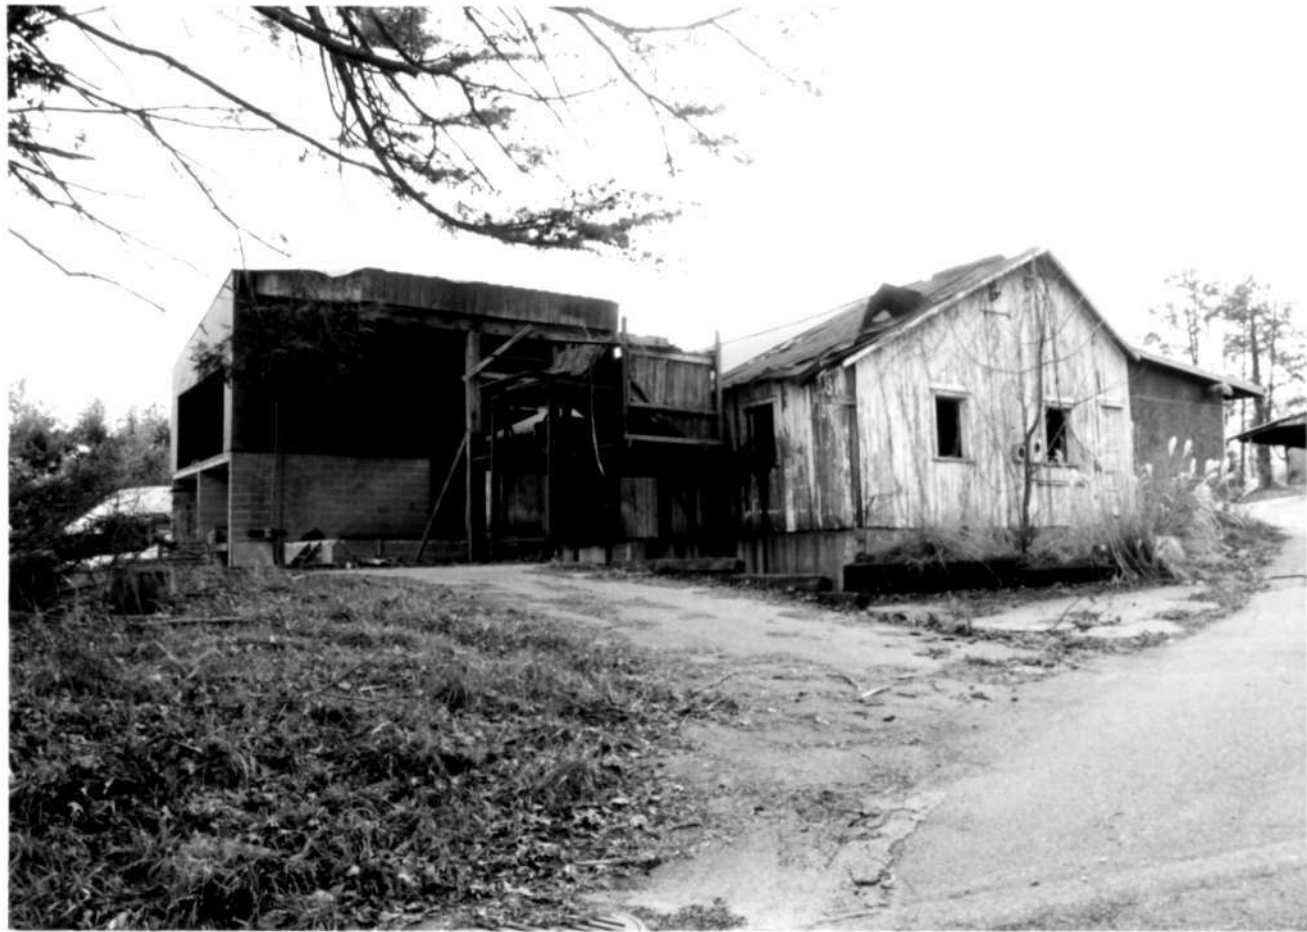
2/24

Original beaded board siding remains on the northwest side elevation and on portions of the rear elevation. The wood framing of the southeast elevation and large sections of the rear elevation were replaced ca. 2000 and are clad with T1-11 or vertical board siding. The rear elevation has two window openings, a double wood door, and a sliding wood door that opens onto a service drive and a loading dock. The northwest elevation retains a five-panel wood door and two window openings with simple wood surrounds.

Cider Mill, view S

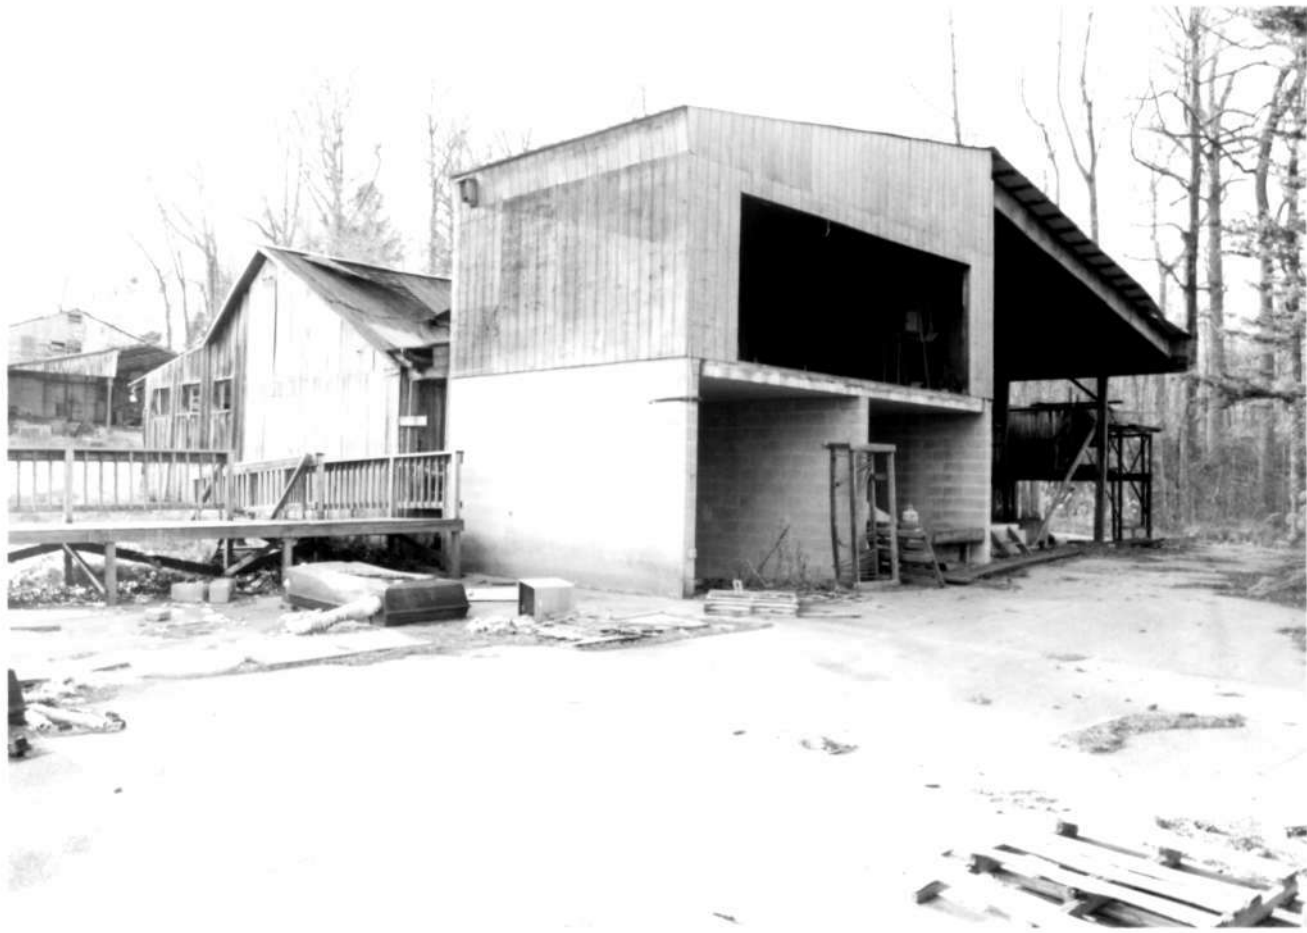
3/24

The front addition was constructed ca. 1970. The wood-frame addition was integrated into the principal block and has a shed roof. The west and south corners are clad with T1-11 and board-and-batten siding, respectively. A ribbon of seven, six-light, wood-frame windows spans the middle three structural bays. The ribbon of windows intersects two single wood doors and one double wood door. The south corner of the addition has three casement windows on the front (southwest) and southeast elevations.

Cider Mill, view W

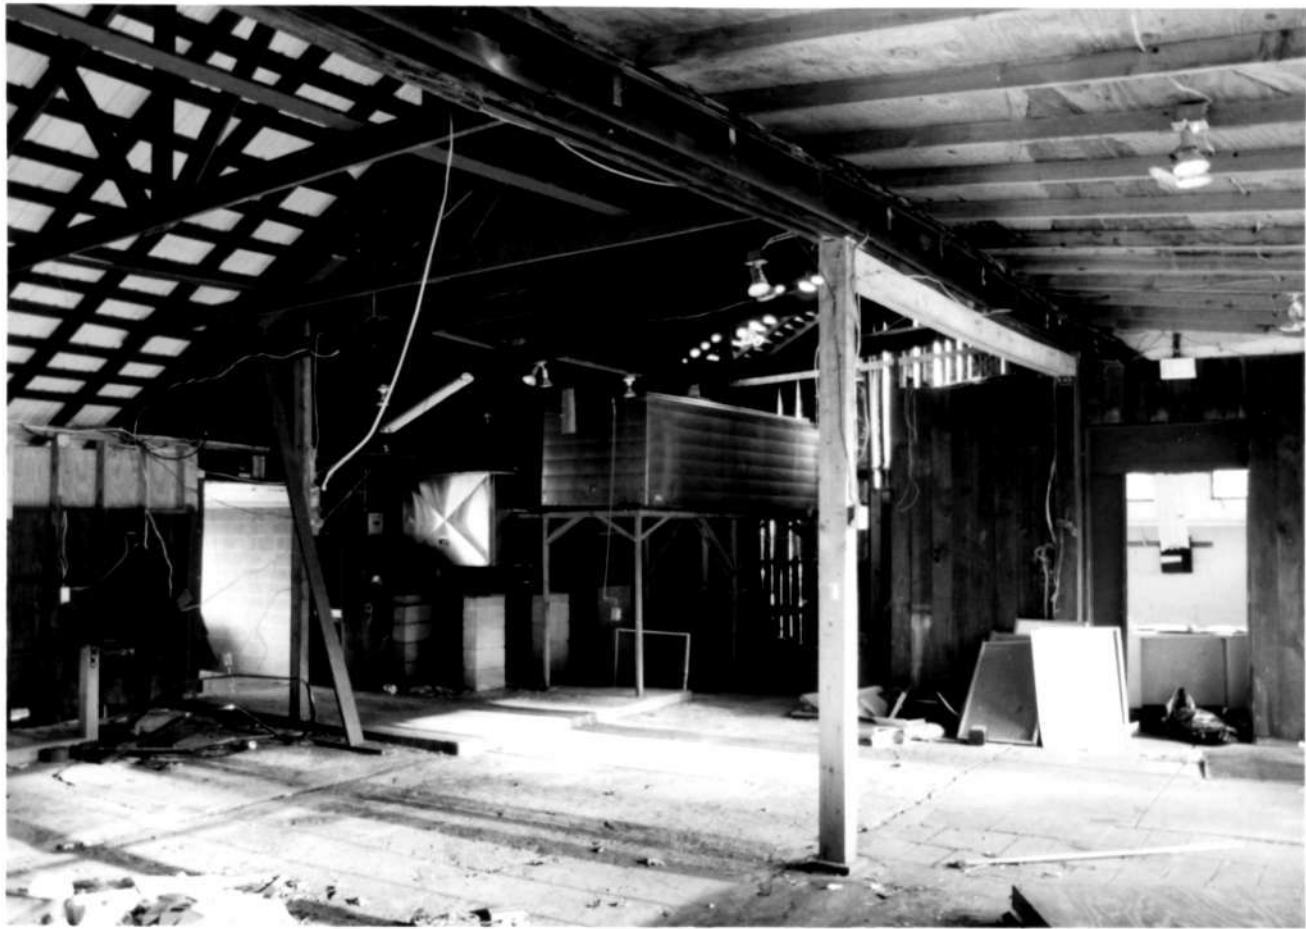
4/24

All equipment related to cider manufacture has been removed with the exception of three refrigerated vats. No interior buildouts survive to document the industrial process. The building is in fair condition. Much of the structure has been replaced over time with new materials. The roof is failing as evidenced by holes in the cladding and windows are broken.

Cider Mill interior, view E

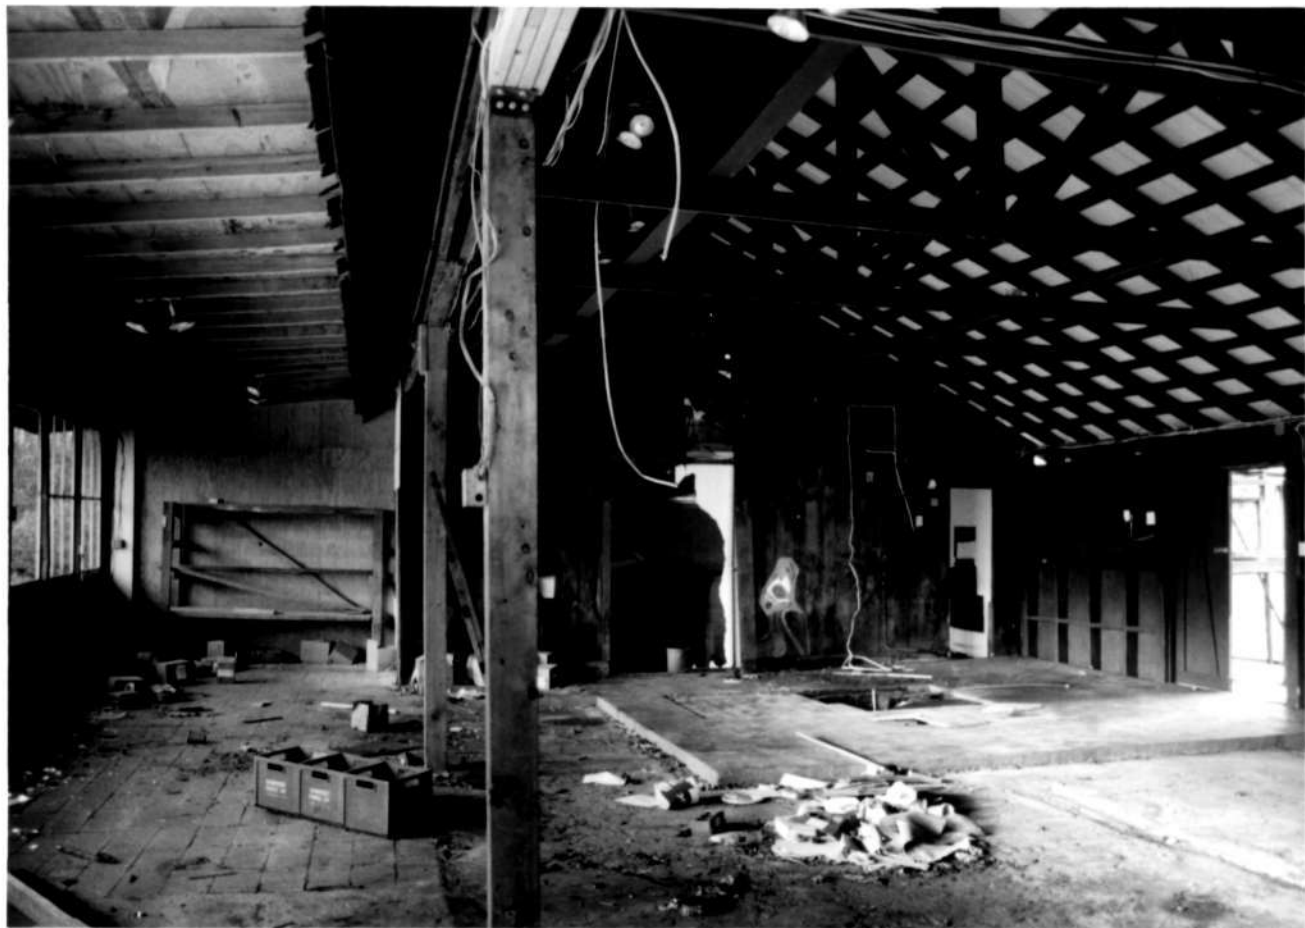
5/24

Cider Mill interior, view N

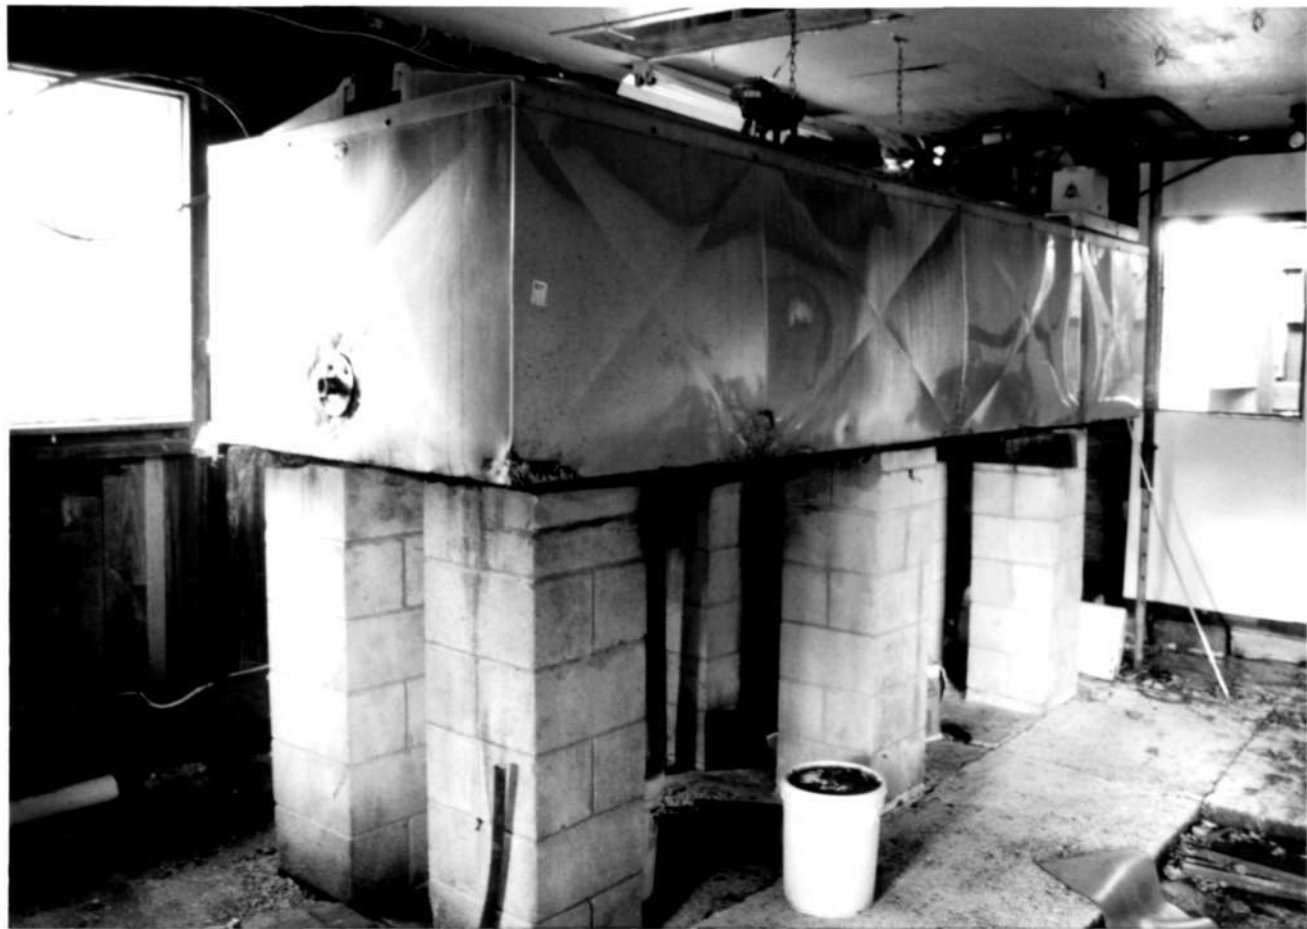
6/24

Cider Mill interior, view N

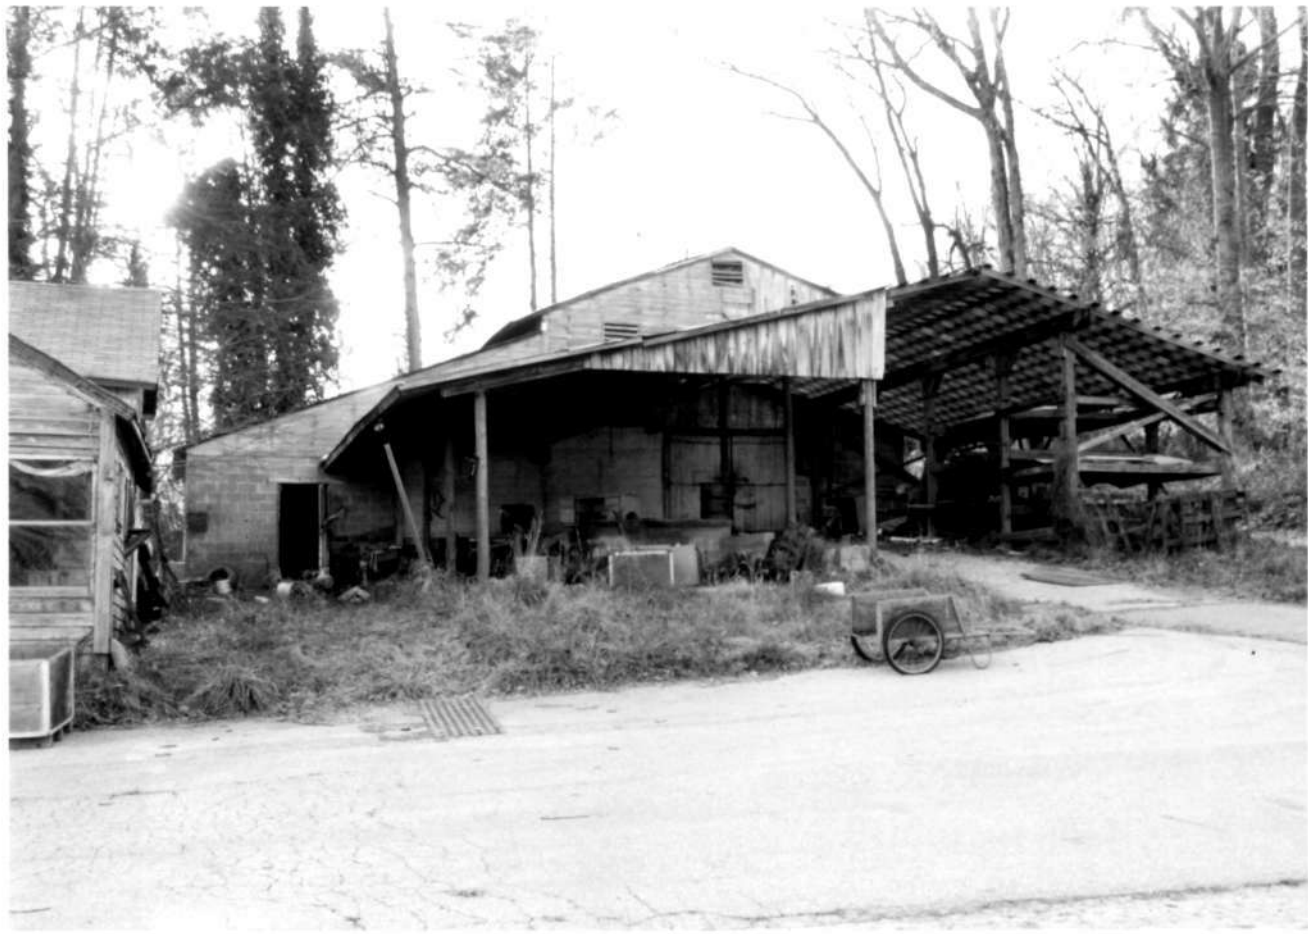
7/24

The **storage building** is located across the asphalt parking lot from the cider mill and faces northeast. The one-story, rectangular, wood-frame building was constructed ca. 1916 and rests on a concrete-block foundation with a skim coat of concrete. The walls are clad in board-and-batten and replacement T1-11 siding. The front-facing gable roof is sheathed with composition roll roofing. The front elevation has three louvered openings. The windows are on the side elevations and are fixed, six-light, wood-sash units with simple wood surrounds. The building has central double wood doors on the front and rear elevations. The rear doors were replaced with a sliding door. A small, ca. 1916, concrete-block workshop is appended to the southeast side elevation at the front of the building. The building has a shed roof and an off-center door opening. A ca. 1995, open, gable-roof, material shed is found in front of the building. Round and square wood posts support the roof. The building is in fair condition. Much of the wood framing and exterior siding has been replaced. The roof is failing.

Storage Building, view SW

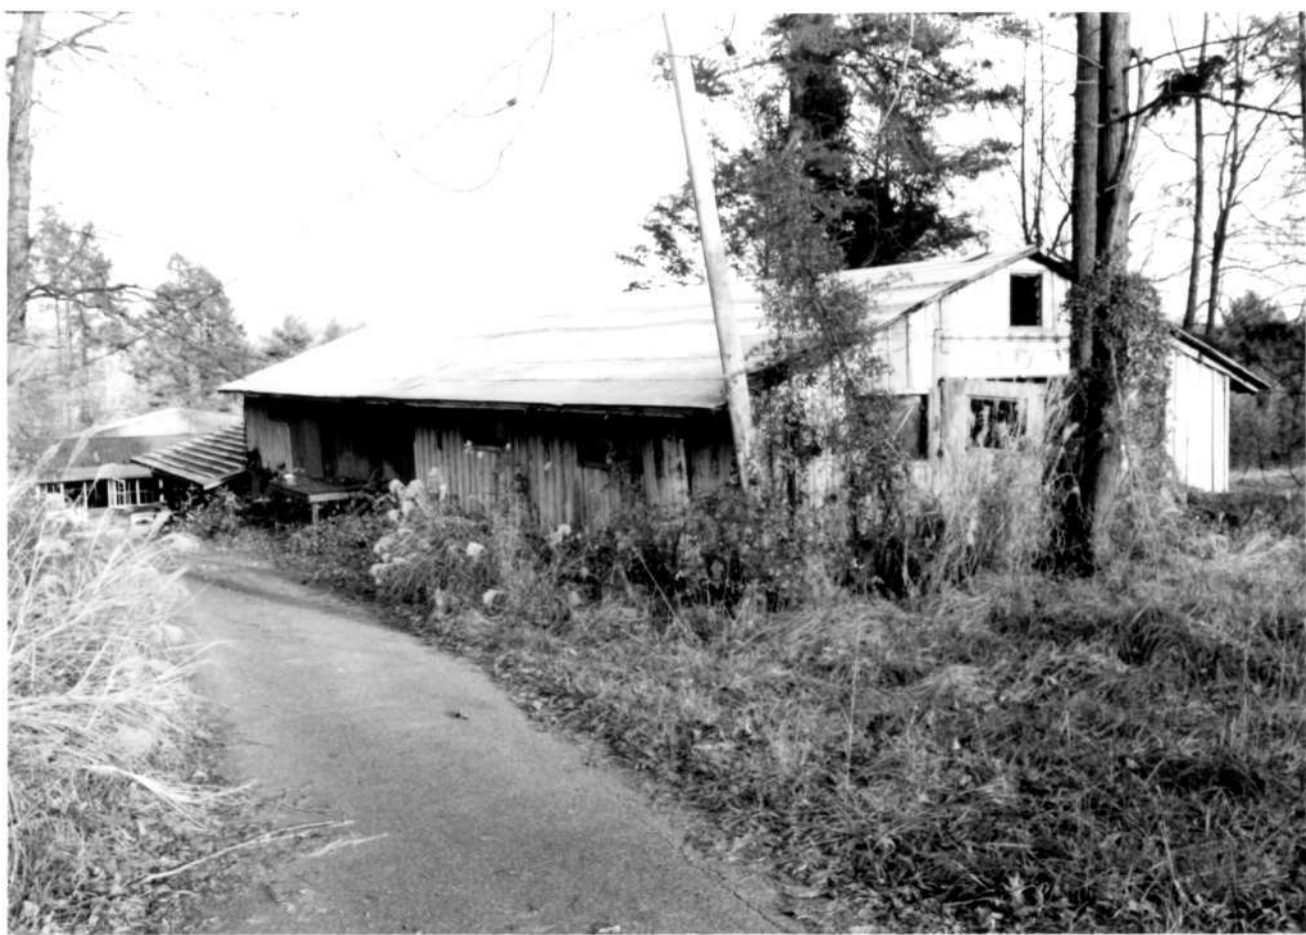
8/24

Storage Building, view E

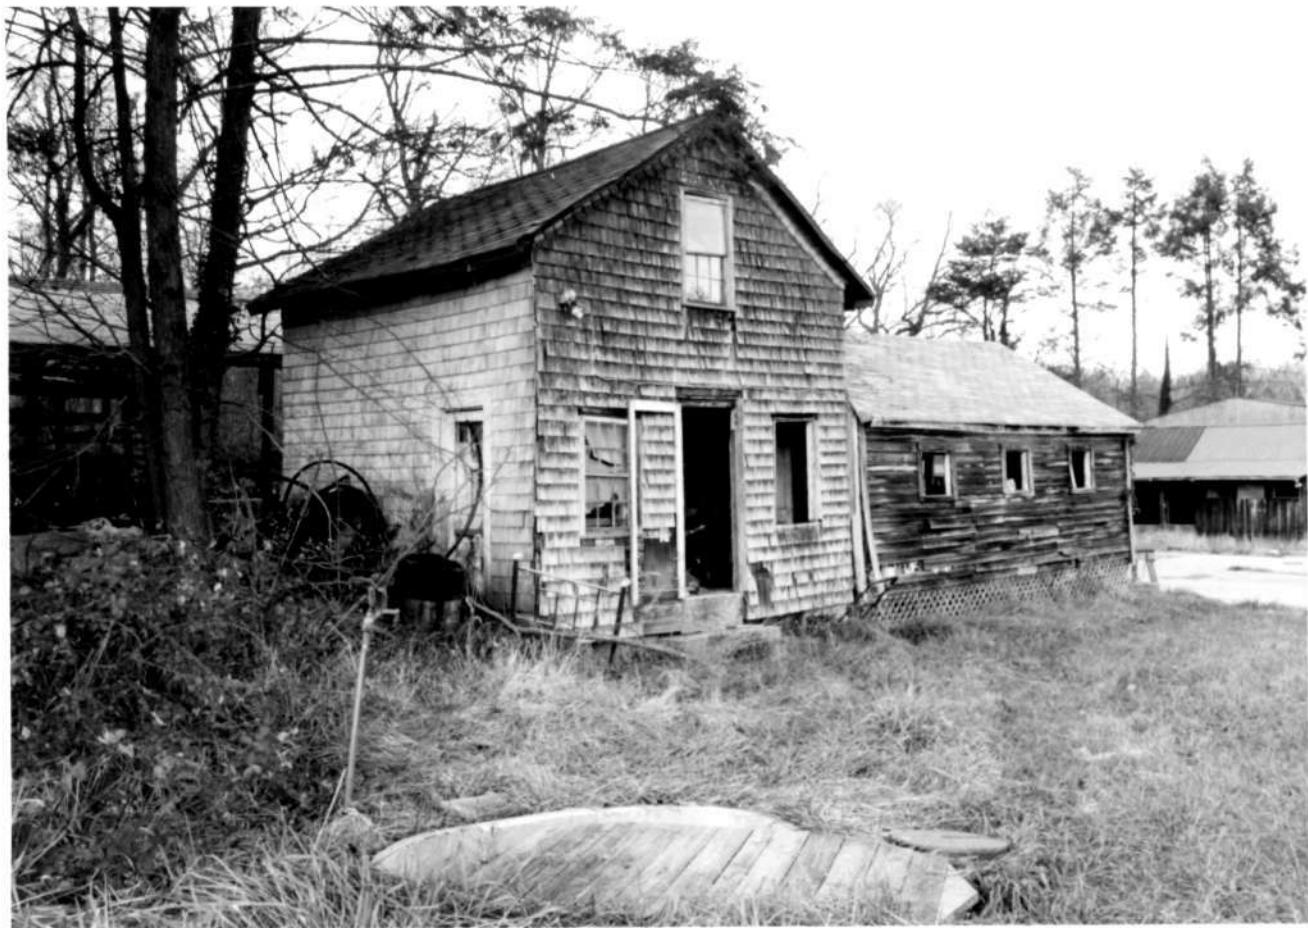
9/24

A 1916, wood-frame **workers' house** is located adjacent to the storage building next to the parking lot. The one-and-one-half-story, front-gable house faces southeast and includes a one-story, side-gable addition on the northeast elevation. The square principal block and the rectangular addition rest on a concrete-block basement and concrete-block piers, respectively. The walls are clad with wood shingles and the roof is sheathed with asphalt shingles. A chimney is located in front of the addition's roof ridge. The windows are fixed, six-over-six-light, wood-sash units. Large, fixed, one-over-one-light, wood-sash windows were installed in the north corner of the addition ca. 1985. The principal block has central front and rear doors, and the addition has an off-center rear entrance. The wood doors have four panels. The principal block and the addition have single cells. The interior of the principal block is unfinished; the structural system is exposed. The building is in poor condition. Doors, windows, and the basement stairs are missing, the foundation is collapsing, portions of the floor are missing, and the siding is rotting.

Workers House, view N

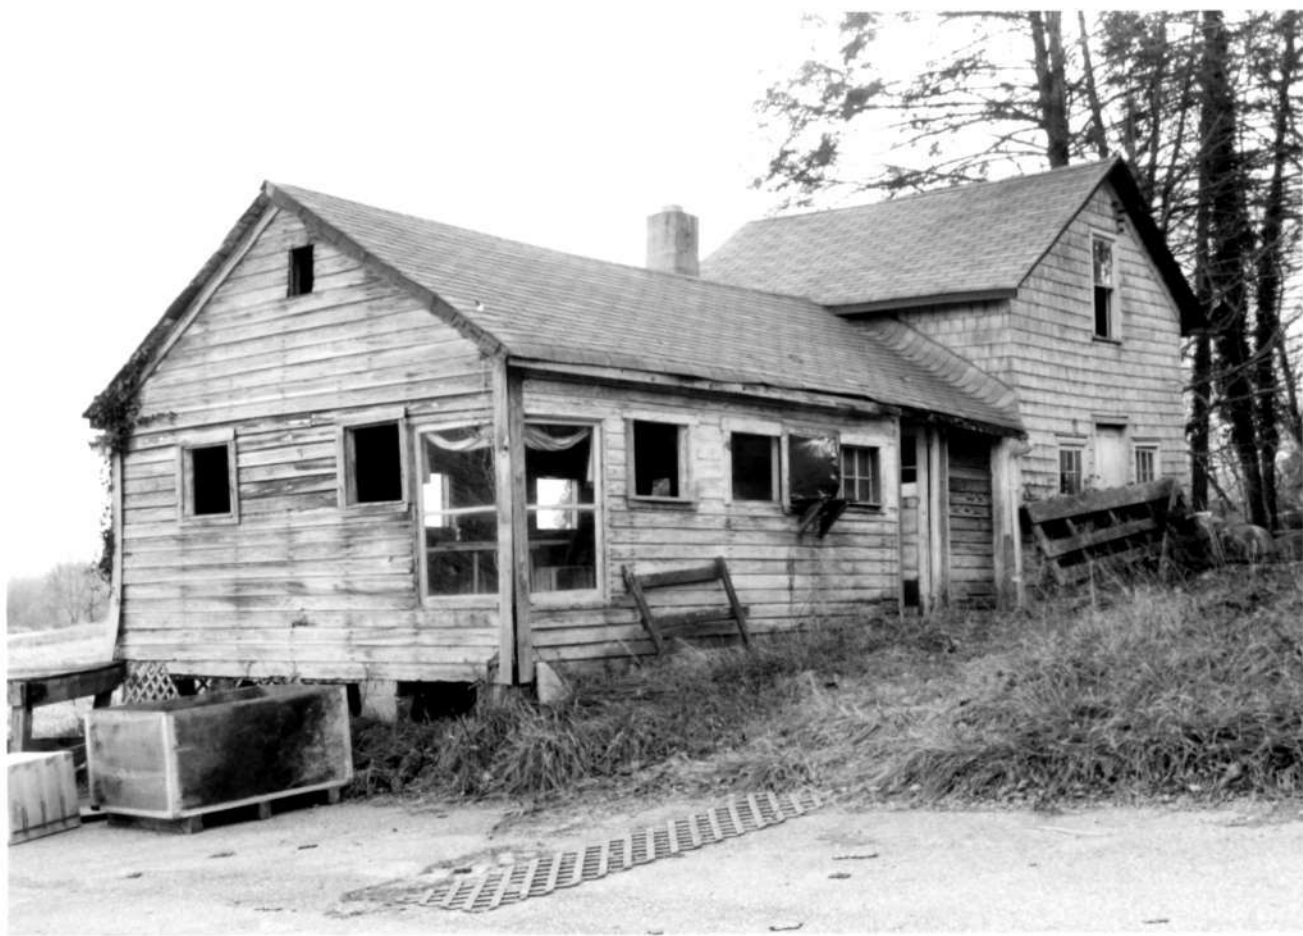
10/24

Workers House, view S

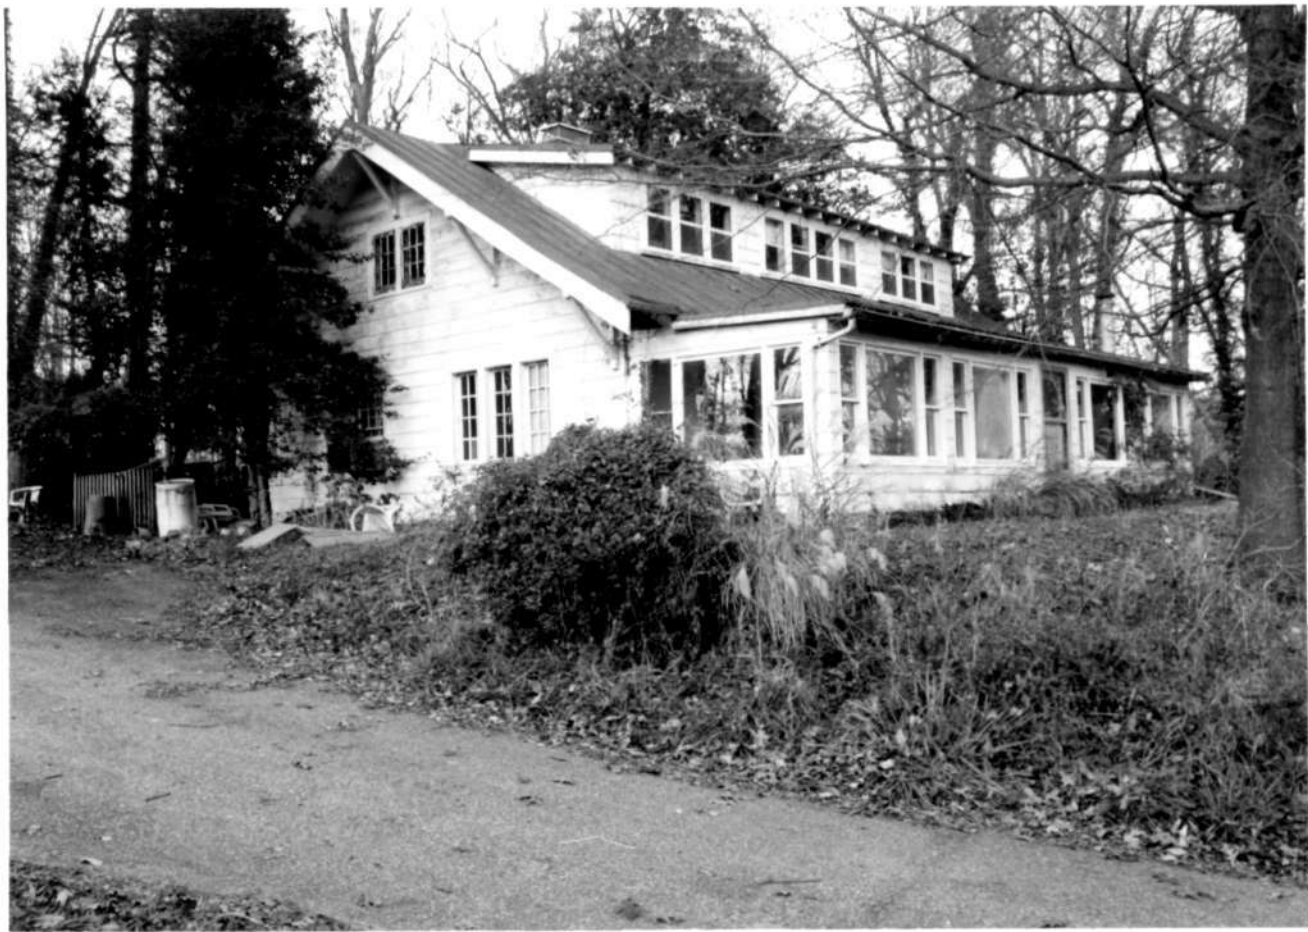
11/24

The main house was constructed ca. 1915 and incorporates features of the early twentieth century Craftsman style. The wood-frame, one-and-one-half-story house faces southeast and occupies a rectangular footprint. A full basement with rubble-stone walls supports the house. The original front porch has been enclosed. The exterior walls of the house and porch are clad with eight-to-ten-inch horizontal wood siding. The gable roof is sheathed in standing-seam metal. An interior brick chimney rises on the southwest end of the roof ridge, and a metal smokestack rises on the northeast end of the porch roof. Shed dormers are located on the front and rear elevations of the house. The front dormer features three groupings of storm windows; the original casement windows have been removed. The center grouping has four windows, and the two side groupings have three windows each. The rear dormer features casement windows. A set of four occupies the center, and a single casement window flanks the center grouping on each side. Rafters are exposed on the eaves of the dormers, the enclosed front porch, and the rear elevation. The side elevations have plain eave boards and brackets.

Main House, view N

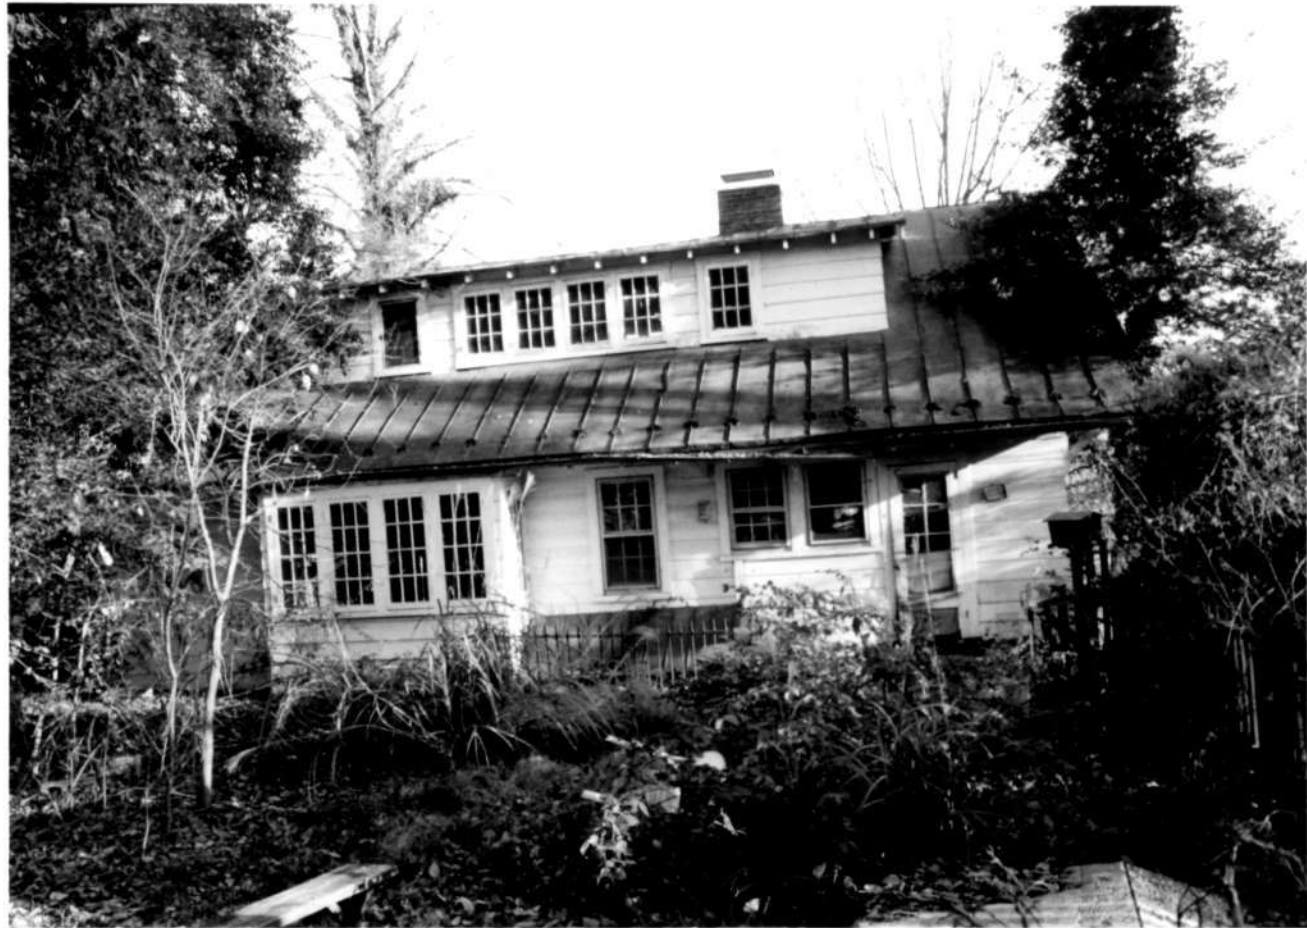
12/24

A single, centered front door is located on the enclosed front porch. This wood door has a single light in the top half. The enclosed front porch has a brick and concrete foundation, a flagstone floor, and a shed roof. The porch contains a series of picture windows on each side of the front door. Various arrangements of wood-frame, nine-light and twelve-light, casement windows and wood-frame, six-over-six-light, double-hung sash windows occur on the remaining elevations of the house. The rear elevation features a wood door with eight lights and a bay window consisting of six, wood-frame, twelve-light, casement windows.

Main House, view SE

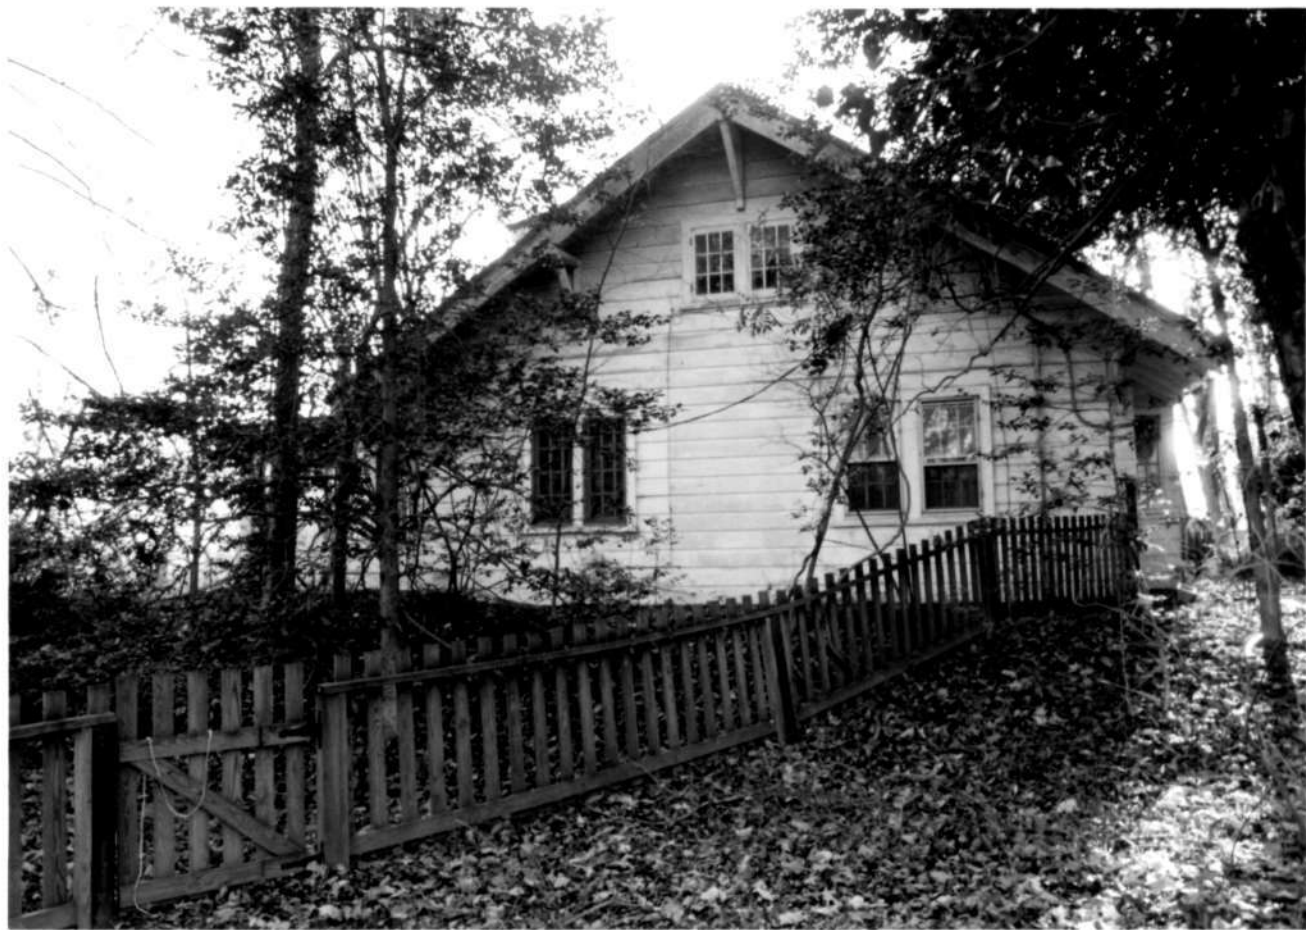
13/24

Main House, view SW

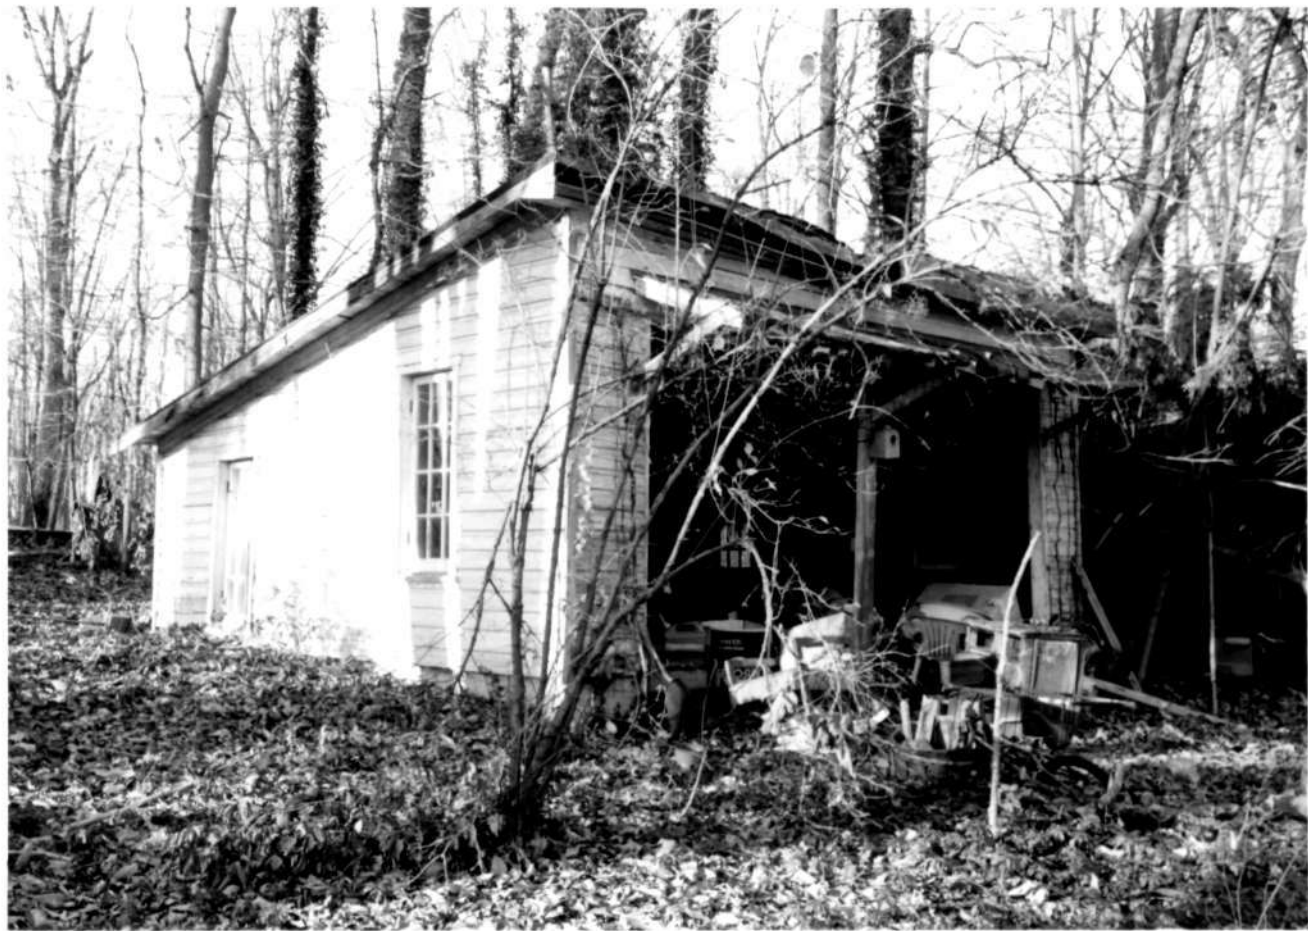
14/24

The **garage**, constructed ca. 1915, is located west of the house. The wood-frame, one-story building faces southeast and occupies a square footprint. The garage rests on a concrete-block foundation. Exterior walls are clad with drop wood siding. The shed roof is sheathed in tarpaper and corrugated metal. Rafters are exposed. An awning sheathed in asphalt shingles extends along the front elevation, which remains open with no doors. The building features wood-frame, twelve-light casement windows. The garage is in poor condition, and the roof is failing.

Main House Garage, view N

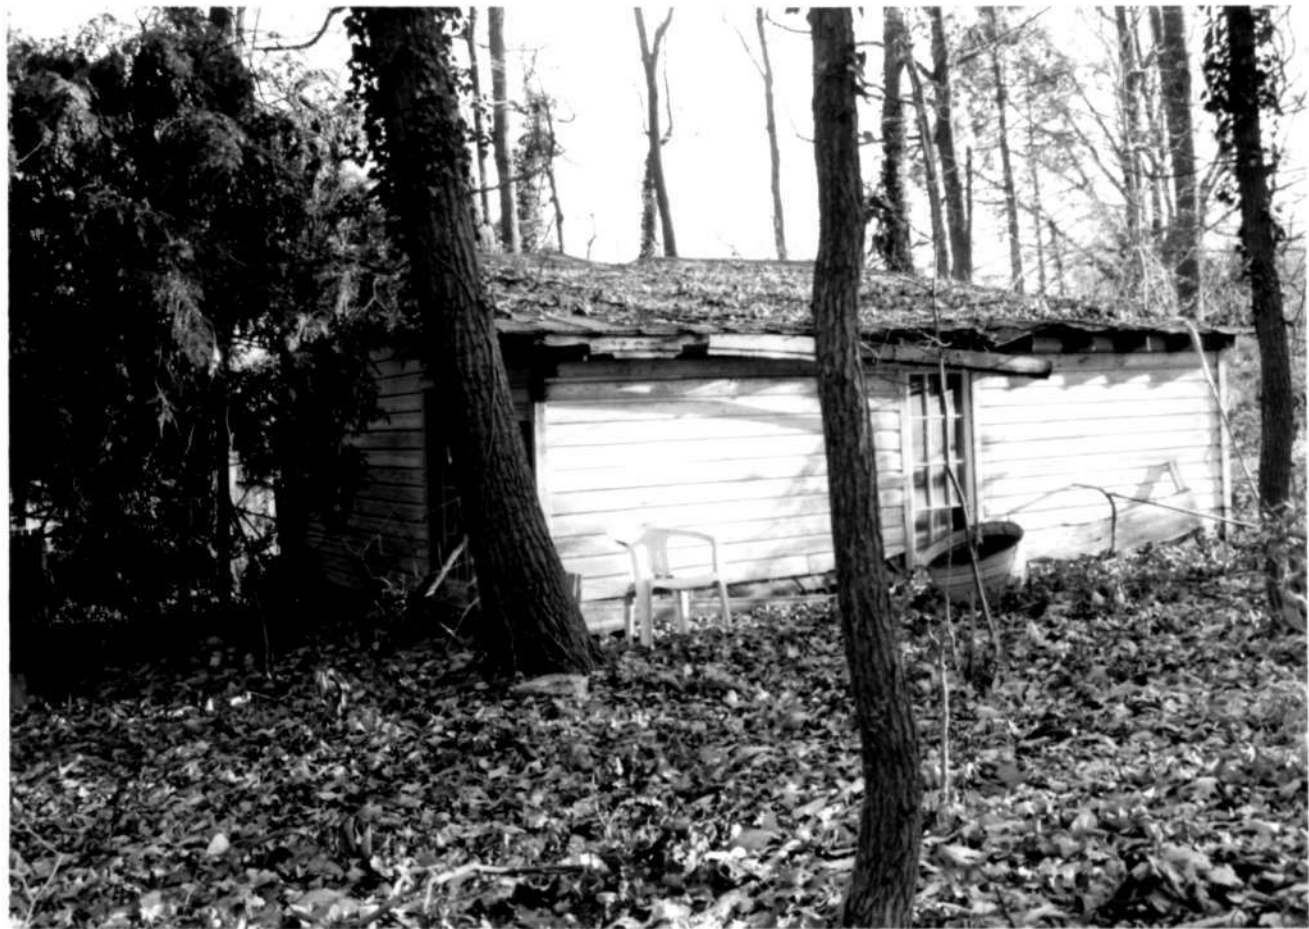
15/24

Main House Garage, view S

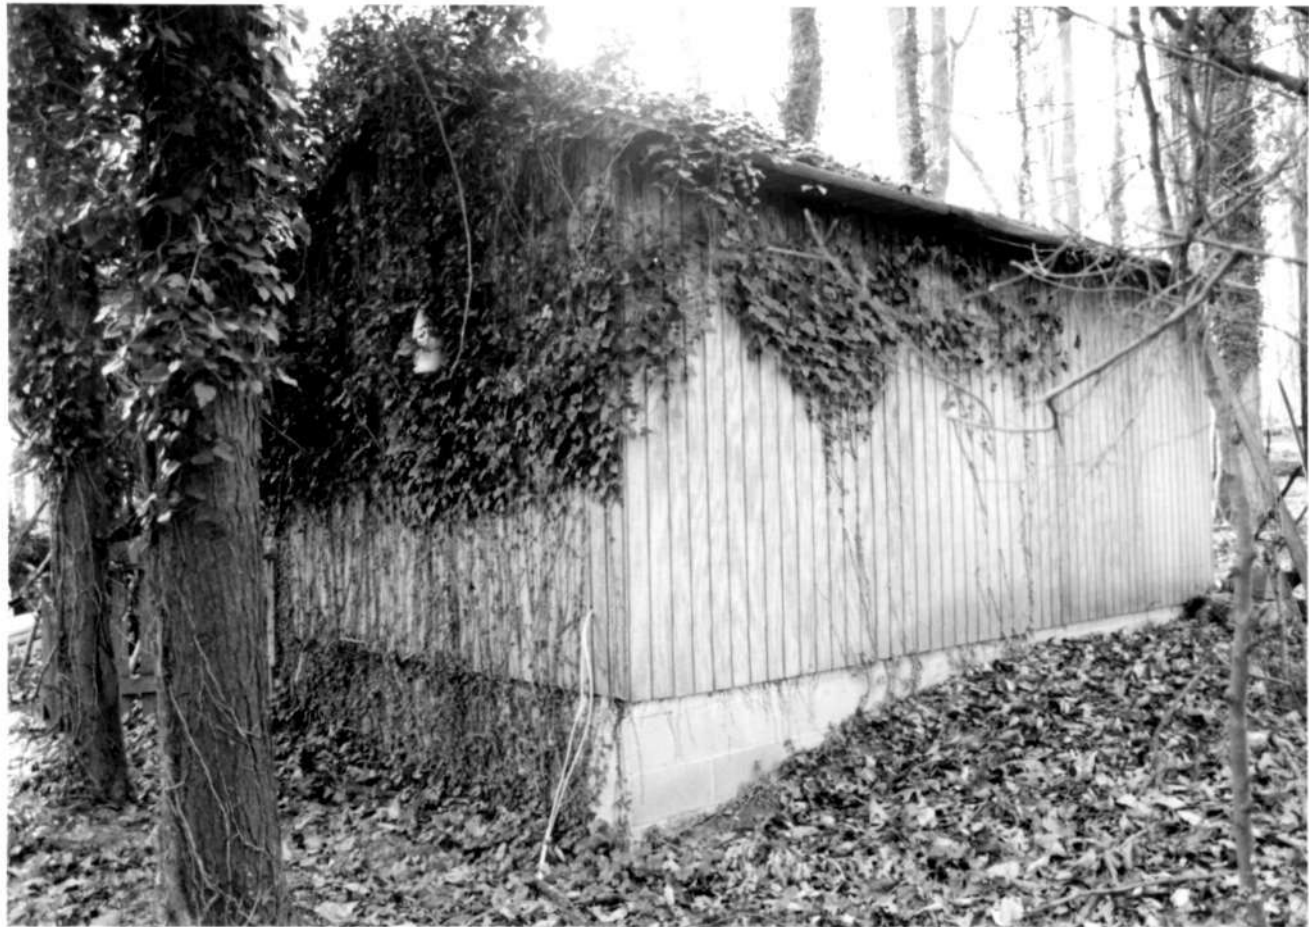
16/24

The **well house**, constructed ca. 1985, is located northwest of the house and northeast of the garage. The wood-frame, one-story building faces southwest and occupies a rectangular footprint. The well house rests on a concrete-block foundation. Exterior walls are clad with vertical T1-11 siding. The shed roof is sheathed in asphalt shingles. The building has a single, off-center door on the front elevation and no windows. The interior walls are partially insulated. The well house is in fair condition. A large tree has fallen on it.

Main House Well House, view W
